Case 245 : Narrative

Case Vehicle (A): 1998 Mercury	Vehicle (B): Unknown Chevrolet
Type: Mystique, 4-door sedan	Type: Pickup
Driver: 39-year-old male	Driver: 45-year-old male
CDC: 12-FYEW-2	CDC: 99-0000-0

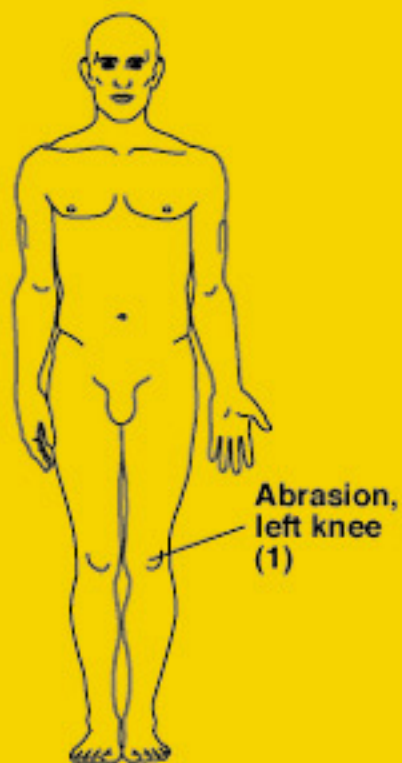
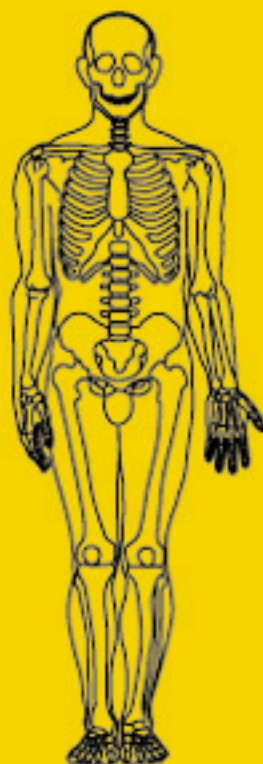
The 5-ft, 3-in, 120-lb, 39-year-old male driver [38](#) [39](#) [40](#) [41](#) was reportedly wearing the three-point belt and the steering-wheel airbag deployed. During the impact, he moved into the shoulder belt and the deploying airbag. [42](#) [43](#) He sustained an abrasion to the left knee from contact with the knee bolster. No other injuries were reported.

Occupant: Driver	Age: 39 years	Gender: Male		
Restraints: 3-point belt worn; airbag deployed	Stature: 160 cm (5 ft, 3 in)	Mass: 54 kg (120 lb)		
Injury Description	A.I.S.	Injury Source		
—	—	Definite	Probable	Possible
Abrasion, left knee	1	Knee bolster	—	—
Maximum A.I.S. Level	1	—	—	—
Injury Severity Score	1	—	—	—

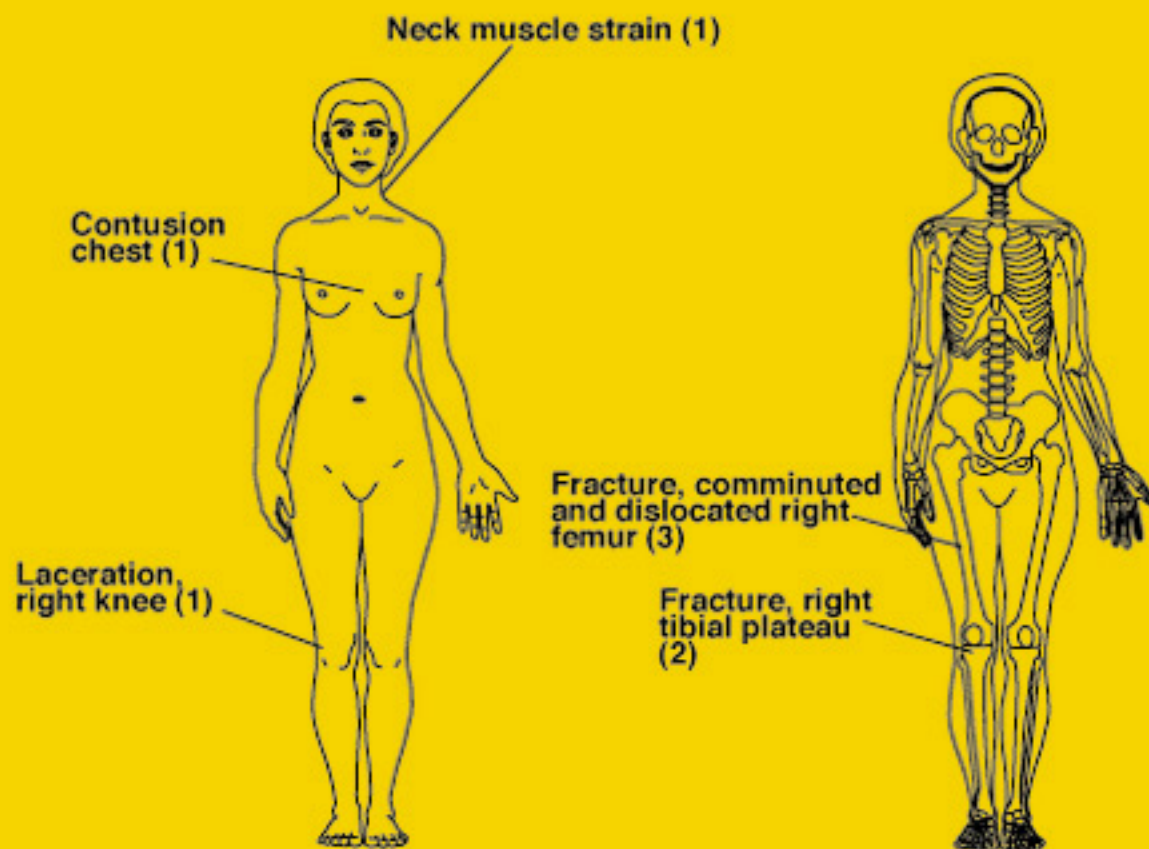
The 5-ft, 4-in, 185-lb, 38-year-old female right-front passenger [44](#) [45](#) was wearing the three-point belt, as indicated by a webbing imprint on the D-ring, and [46](#) the passenger frontal-impact airbag deployed. She was reportedly out of position, leaning to the left while attempting to steer the vehicle. Her right knee was reportedly somewhat elevated and bent as she was attempting to get her left foot onto the brake pedal. During the impact, she moved into the belt restraints and the airbag. She sustained neck muscle strain, probably from impact forces. She sustained a contusion to the chest, probably from loading by the shoulder belt. [47](#) She also sustained a fracture of the right tibial plateau, a displaced comminuted fracture of the right femur, and a laceration to the right knee, probably from contact with the glove compartment area.

Occupant: Right front	Age: 38 years	Gender: Female		
Restraints: 3-point belt worn; airbag deployed	Stature: 163 cm (5 ft, 4 in)	Mass: 84 kg (185 lb)		
Injury Description	A.I.S.	Injury Source		
—	—	Definite	Probable	Possible
Neck muscle strain	1	—	Impact forces	—
Contusion, chest	1	—	Shoulder belt	—
Fracture, right femur, comminuted and displaced	3	—	Glove compartment area	—
Fracture, right tibial plateau	2	—	Glove compartment area	—
Laceration, right knee	1	—	Glove compartment area	—
Maximum A.I.S. Level	3	—	—	—
Injury Severity Score	11	—	—	—

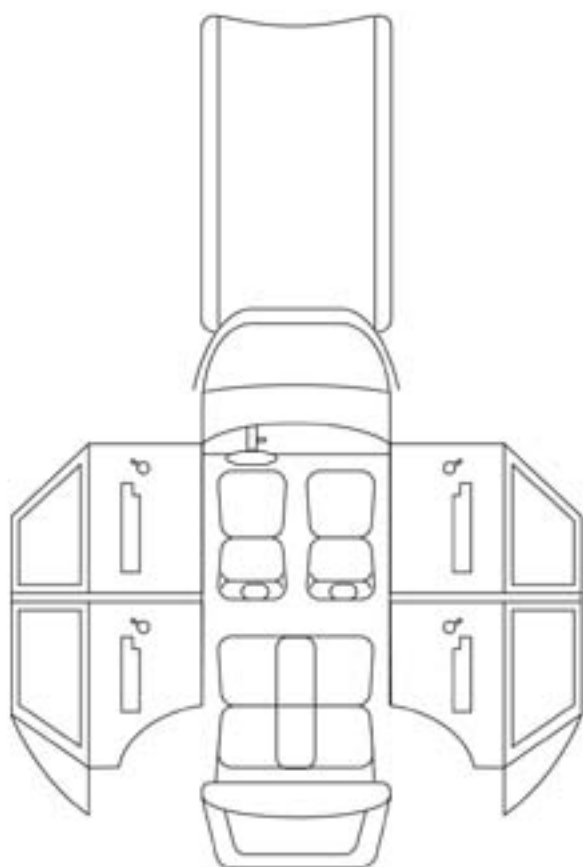
OCCUPANT CONTACT WORKSHEET

Contact	Interior Component Contacted	Occupant No. if Known	Body Region if Known	Supporting Physical Evidence	Confidence Level of Contact Point
A	Knee bolster	1	Knee	Scuff mark	1
B	Center instrument panel	2	Arm	Scuff mark	3
C	Glove box	2	Knee	Latch handle broken	
D	Right instrument panel	2	Unknown	Scuff mark	
E					
F					
G
